**Flood Control Project Maintenance
Levee Inspections****LMA District Cover Sheet****Spring 2013 Levee Inspection Results****Reclamation District No. 0827 Elkhorn**

Levee Inspection Report By Mile - Spring 2013

Reclamation District No. 0827 Elkhorn

Waterway	Bank	Unit Miles	Inspection Start/End	Inspector
Unit No. 01 Sacramento River	Right	1.35		John Williamson

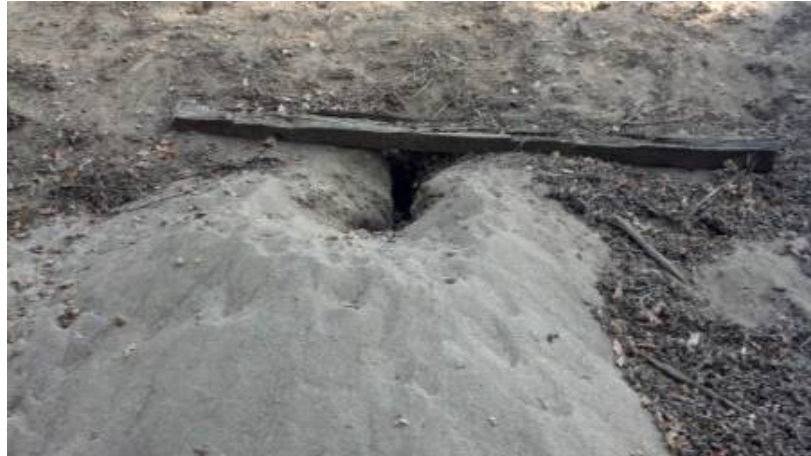
Levee Mile Report Line	4
Start Levee Mile	0.27
End Levee Mile	0.27
Location	Land Side
Category	
Item	Animal Control
A large rodent hole on the levee slope. Photo fall 2012.	
johngw_s_20130221_442.jpg

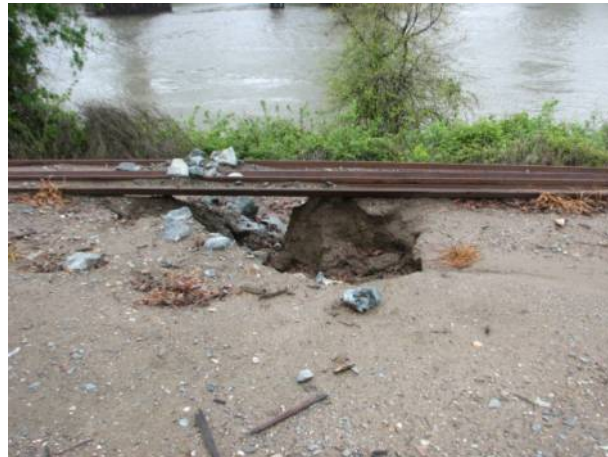
Levee Mile Report Line	5
Start Levee Mile	0.27
End Levee Mile	0.27
Location	Water Side
Category	
Item	Erosion / Bank Caving
The erosion has gotten worst over the winter. Spring 2013	
johngw_s_20130408_914.JPG

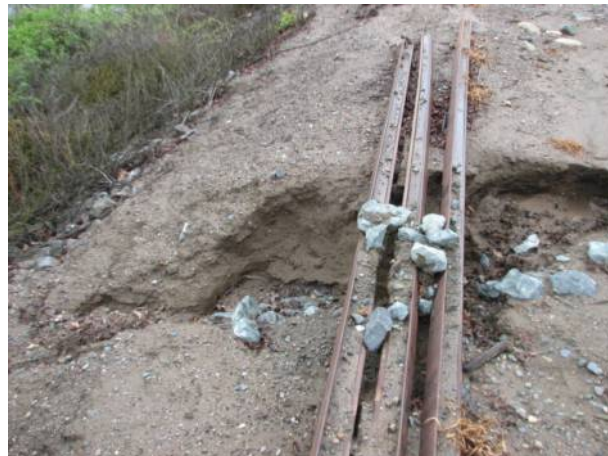
Levee Mile Report Line	5
Start Levee Mile	0.27
End Levee Mile	0.27
Location	Water Side
Category	
Item	Erosion / Bank Caving
The surface run off has increased the erosion damage. Spring 2013	
johngw_s_20130408_915.JPG

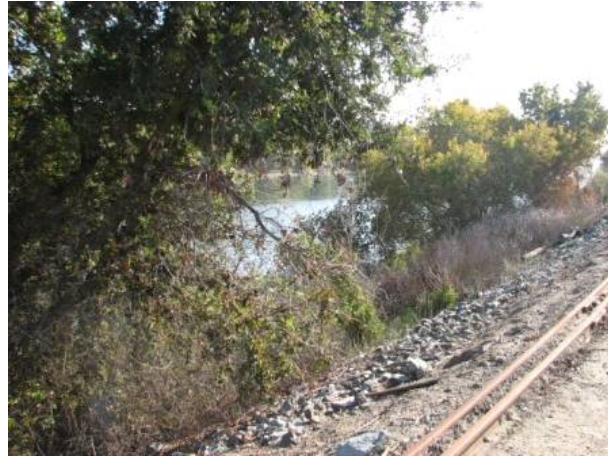
Levee Mile Report Line	6
Start Levee Mile	0.31
End Levee Mile	0.37
Location	Water Side
Category	
Item	Trim / Thin Trees
Thick vegetation on the waterside. Fall 2011	
johngw_s_20130221_439.jpg

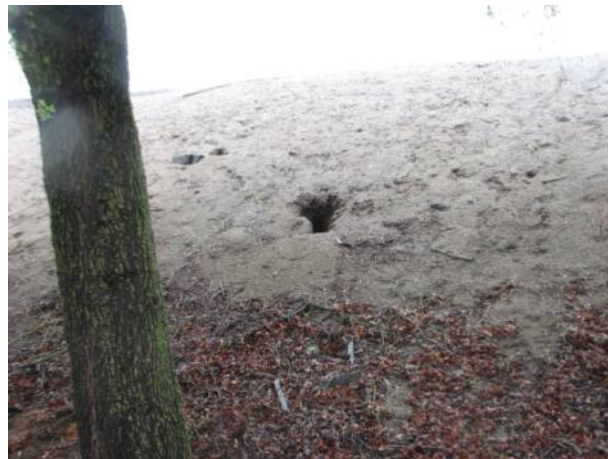
Levee Mile Report Line	7
Start Levee Mile	0.37
End Levee Mile	0.37
Location	Land Side
Category	
Item	Animal Control
A couple of rodent holes on the landside levee slope. Spring 2013	
johngw_s_20130408_920.JPG

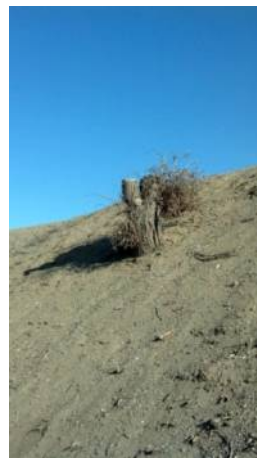
Levee Mile Report Line	8
Start Levee Mile	0.54
End Levee Mile	0.54
Location	Land Side
Category	
Item	Trim / Thin Trees
A tree stump on the levee slope. Photo fall 2012.	
johngw_s_20130221_445.jpg

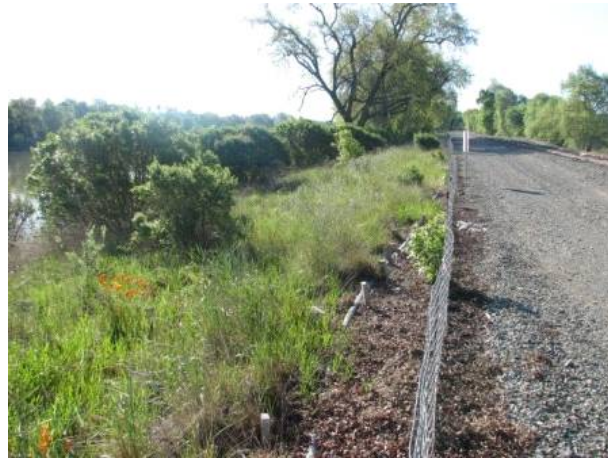
Levee Mile Report Line	10
Start Levee Mile	0.61
End Levee Mile	0.92
Location	Water Side
Category	
Item	Vegetation
Revegetaion site with fencing, irrigation and stakes to hold netting. Photo taken spring 2012.	
johngw_s_20130221_446.jpg

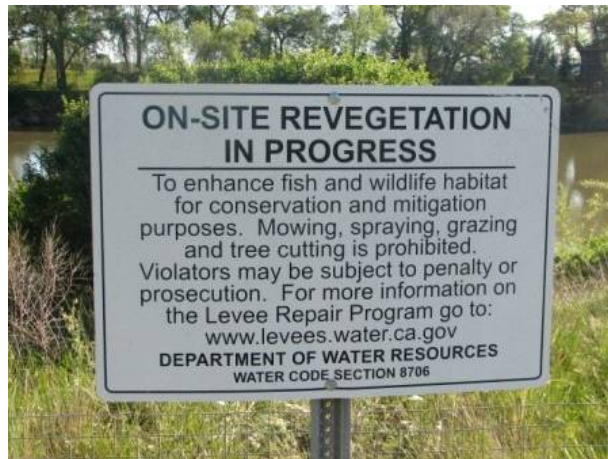
Levee Mile Report Line	10
Start Levee Mile	0.61
End Levee Mile	0.92
Location	Water Side
Category	
Item	Vegetation
Revegetation site spring 2012.	
johngw_s_20130221_447.jpg

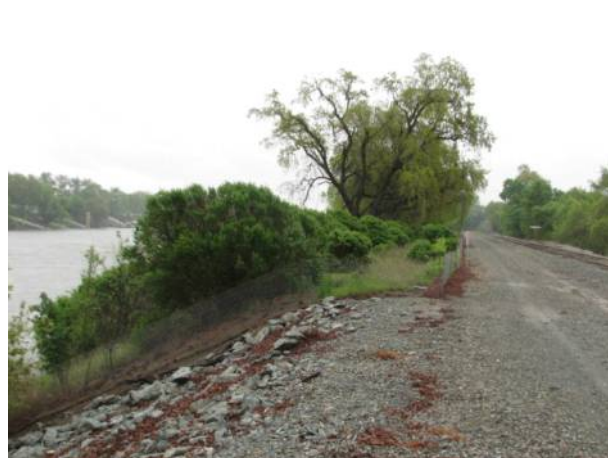
Levee Mile Report Line	10
Start Levee Mile	0.61
End Levee Mile	0.92
Location	Water Side
Category	
Item	Vegetation
The revegetation site has grown and blocks visibility. Spring 2013	
johngw_s_20130408_916.JPG

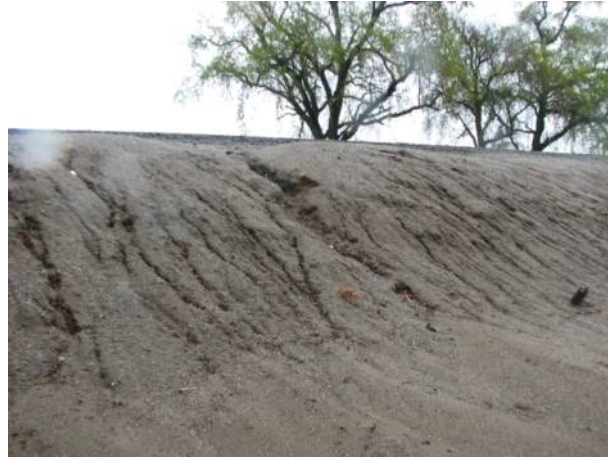
Levee Mile Report Line	11
Start Levee Mile	0.65
End Levee Mile	0.65
Location	Land Side
Category	
Item	Erosion / Bank Caving

The surface and impact erosion has gotten worst. Spring 2013

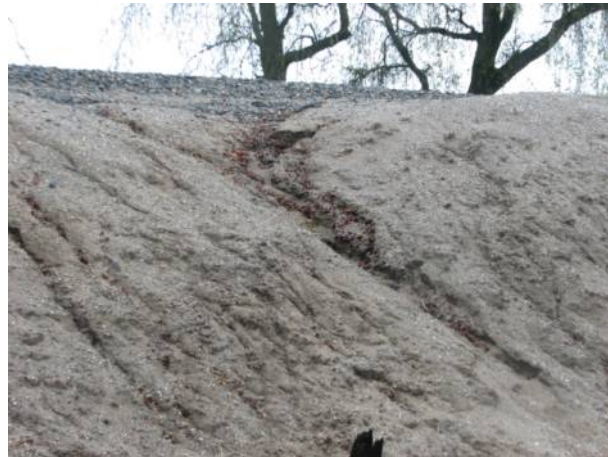
Levee Mile Report Line	11
Start Levee Mile	0.65
End Levee Mile	0.65
Location	Land Side
Category	
Item	Erosion / Bank Caving

Erosion with the depth greater than 3" but less than 1'. Spring 2013

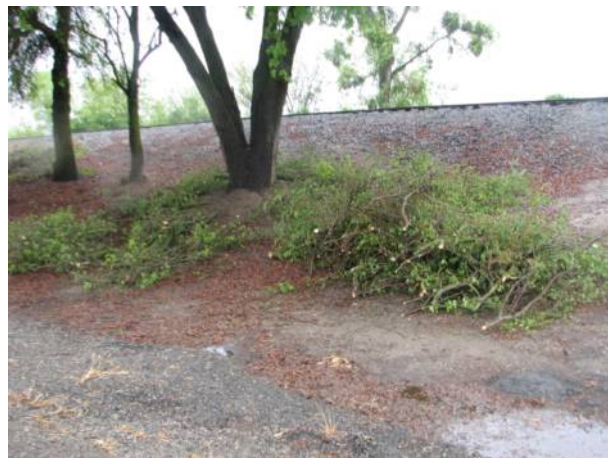
Levee Mile Report Line	13
Start Levee Mile	0.90
End Levee Mile	0.90
Location	Land Side
Category	
Item	Encroachments

The trees are being trimmed and the brush piles need to be removed. Spring 2013

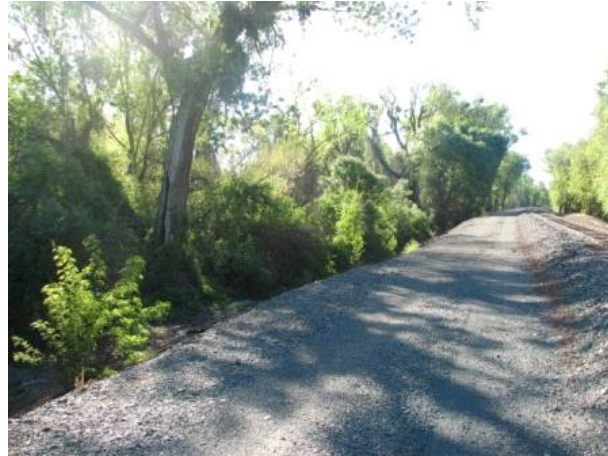
Levee Mile Report Line	14
Start Levee Mile	0.92
End Levee Mile	1.33
Location	Water Side
Category	
Item	Vegetation

Trees on the very wide waterside berm. Photo taken spring 2012.

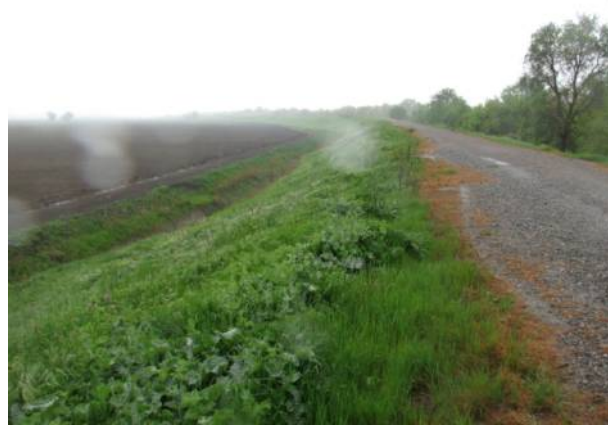
Levee Mile Report Line	1
Start Levee Mile	0.01
End Levee Mile	2.79
Location	Land Side
Category	
Item	Vegetation
The grasses are taller than 12" in height. Spring 2013	
johngw_s_20130408_897.JPG

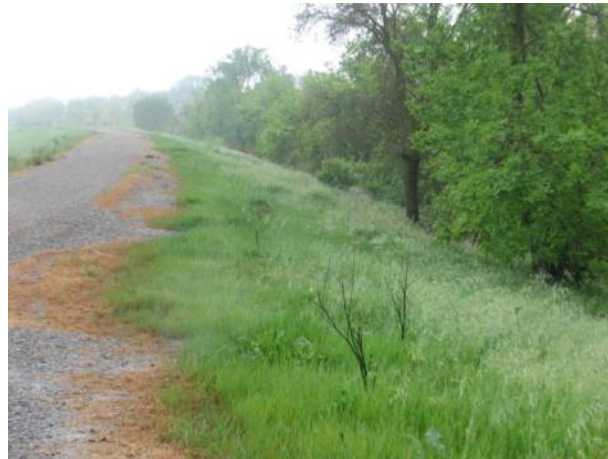
Levee Mile Report Line	2
Start Levee Mile	0.01
End Levee Mile	2.79
Location	Water Side
Category	
Item	Vegetation
The grasses are taller than 12" in height. Spring 2013	
johngw_s_20130408_898.JPG

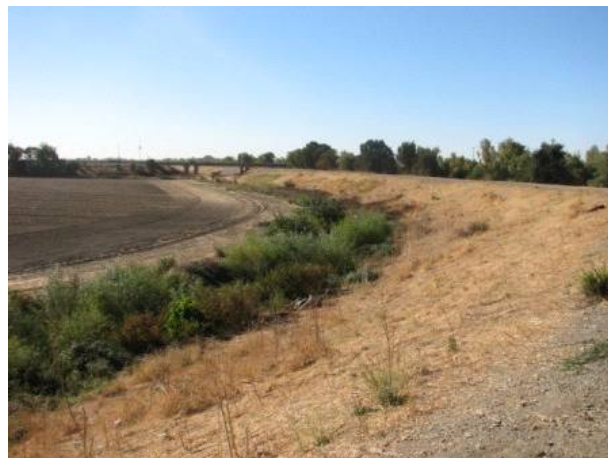
Levee Mile Report Line	3
Start Levee Mile	0.01
End Levee Mile	0.53
Location	Land Side
Category	
Item	Encroachments
Ditch runs along the landside toe. Photo fall 2012.	
johngw_s_20130221_451.jpg

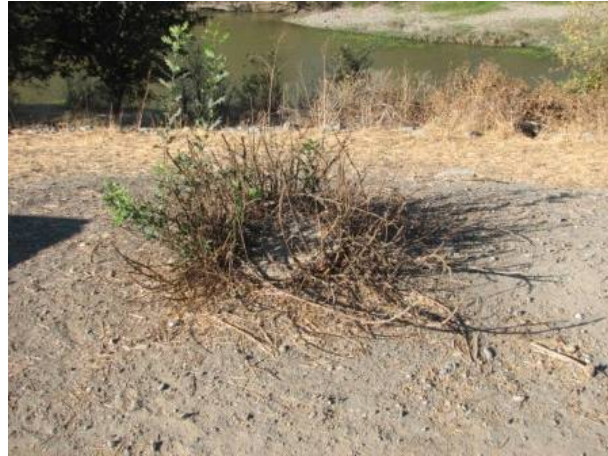
Levee Mile Report Line	4
Start Levee Mile	0.11
End Levee Mile	0.11
Location	Crown
Category	
Item	Trim / Thin Trees

A tree stump on the levee shoulder. Photo fall 2012.

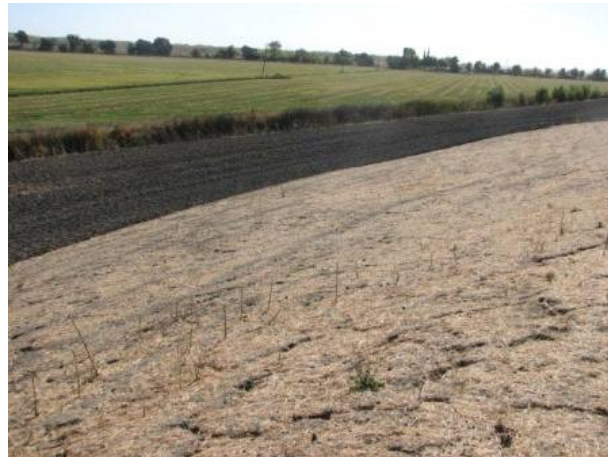
Levee Mile Report Line	8
Start Levee Mile	2.31
End Levee Mile	2.31
Location	Land Side
Category	
Item	Slope Stability

A buldge in the levee slope. Photo fall 2012.
